INCIDENT REPORT

INSPECTION #: 1567974 **REPORT DATE:** March 8, 2022
1568109

The Ridge Incident: Firefighter Dies in House Fire After First Floor Collapse and Loss of Accountability

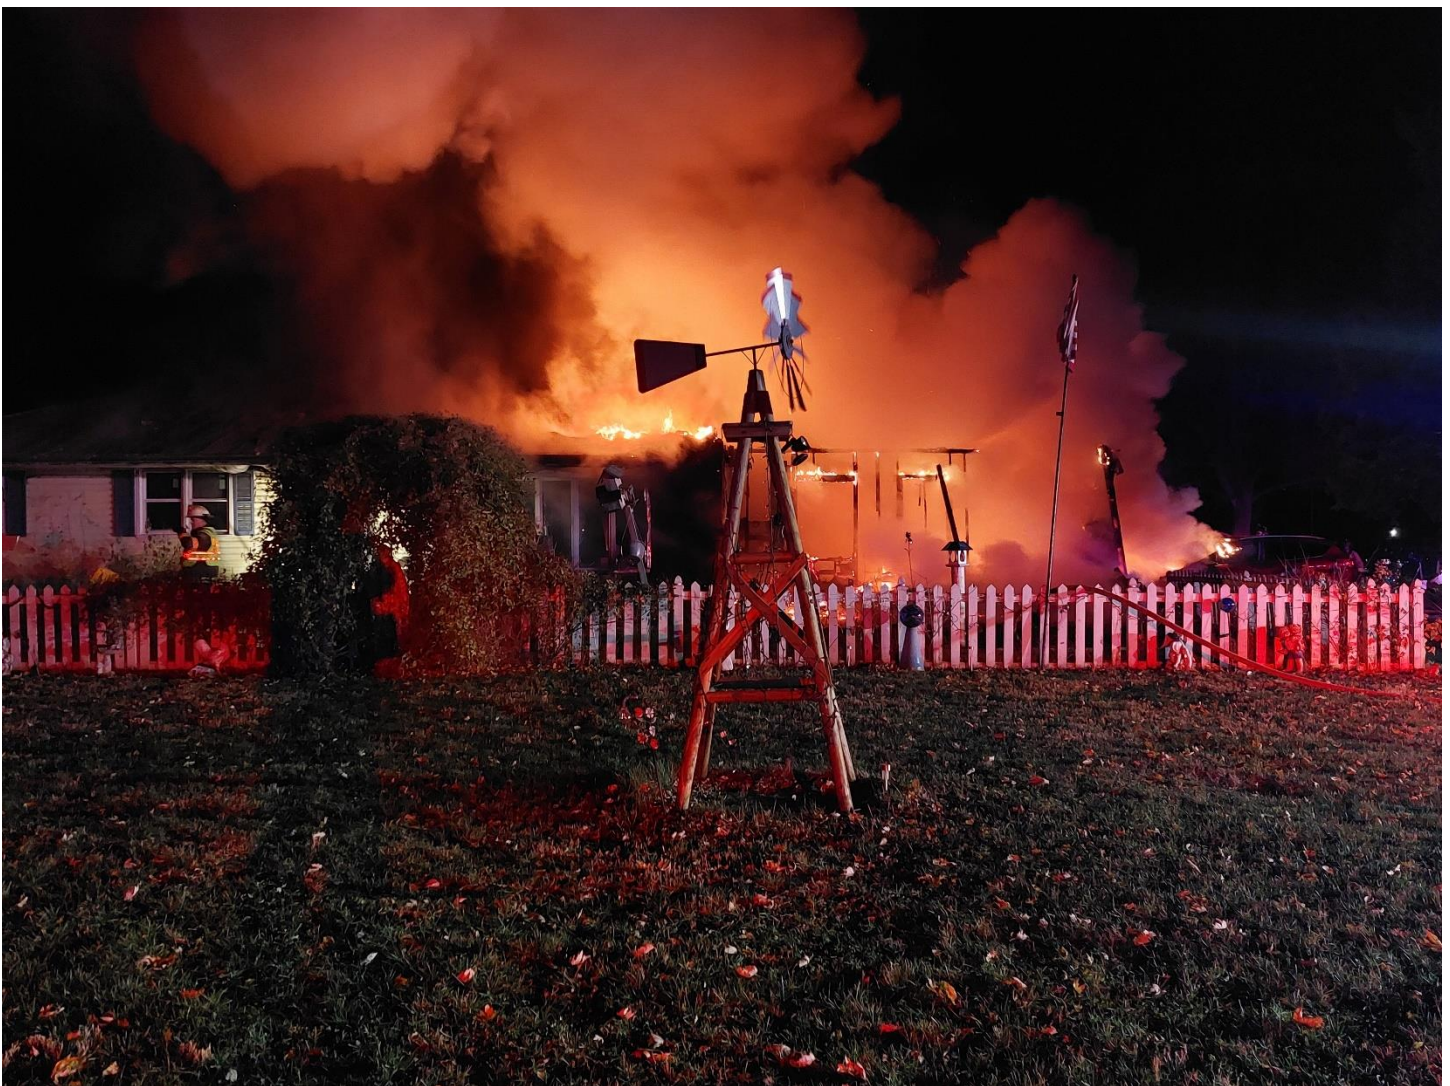
Figure 1 - "Alpha" side of residence at 11:28 PM (photo credit: Heather Smith - Eye on News)

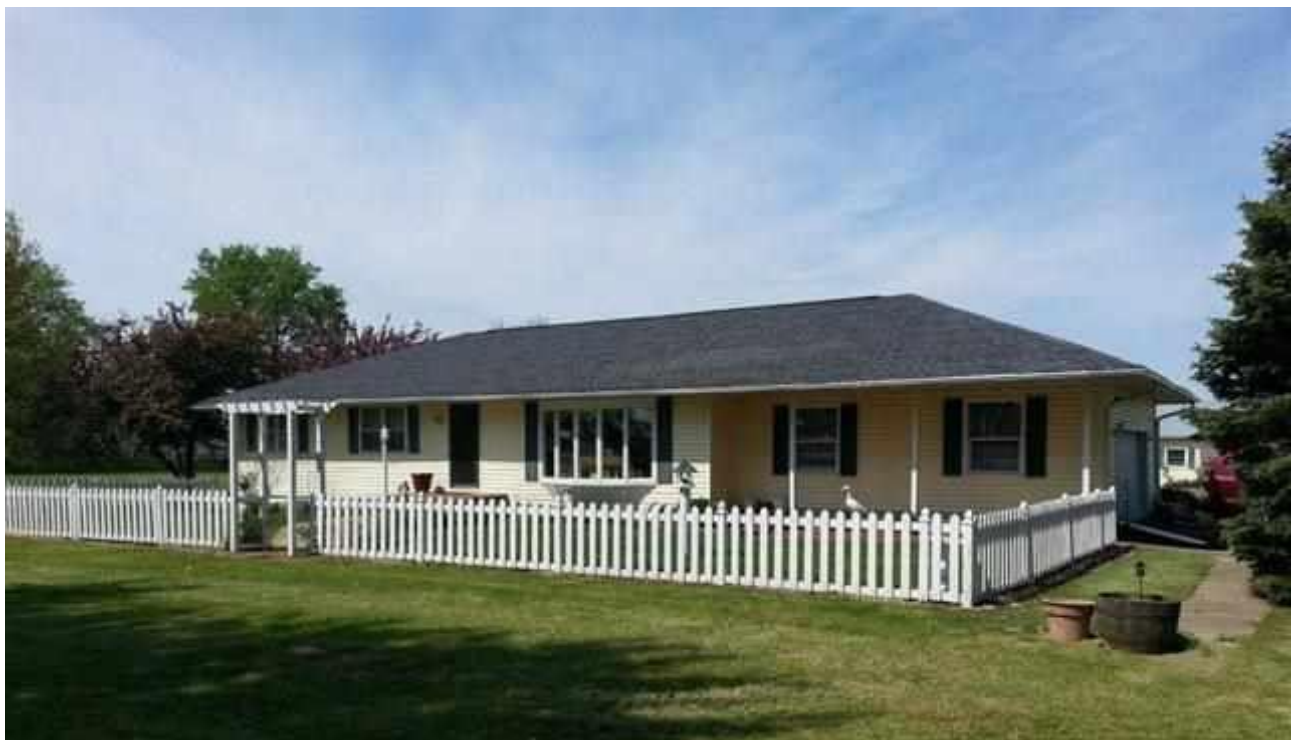
Figure 2 - Undated photo of "Alpha" side of residence (photo credit: Realtor.com)

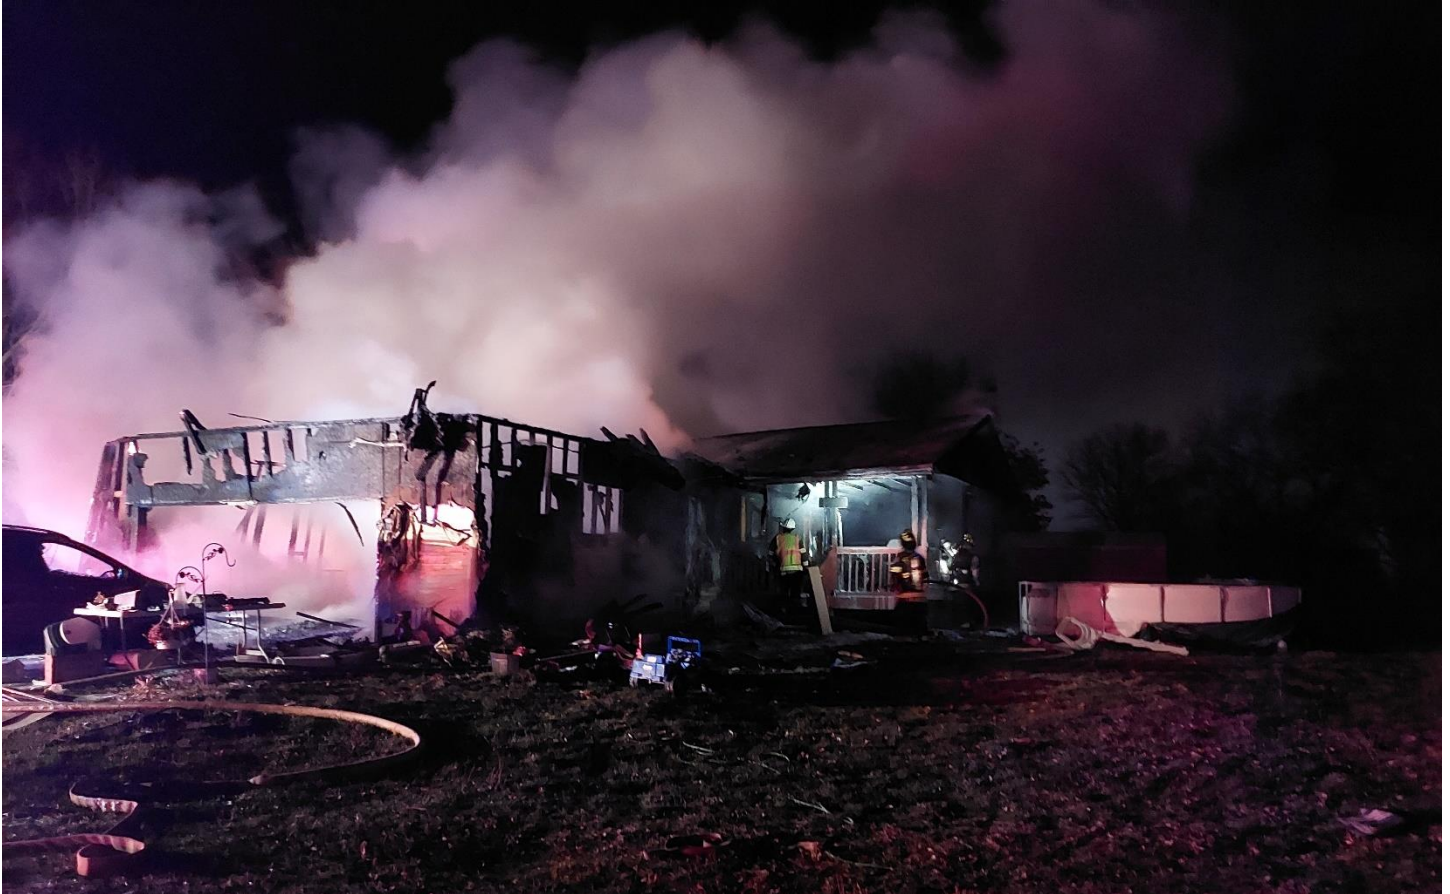
Figure 4 - "Charlie/Delta" side of residence at 11:56 PM (photo credit: Heather Smith, Eye on News)

After the PAR event, deteriorating conditions indicated the potential presence of a basement fire. At this point, at least forty minutes after arrival of the first unit, command had not confirmed the presence or absence of a basement. The incident commander then confirmed with the homeowners that there was a basement. A crew of two with FD #2 assigned to the exterior "Charlie" side were re-assigned to make entry into the basement. Once at the bottom of the basement stairs, the crew reported that they could not advance into the basement due to debris from the floor collapse.
