# SELECT STRUCTURAL

RE: Brick Wall Inspection  
324 N. Main St.  
Davenport, IA

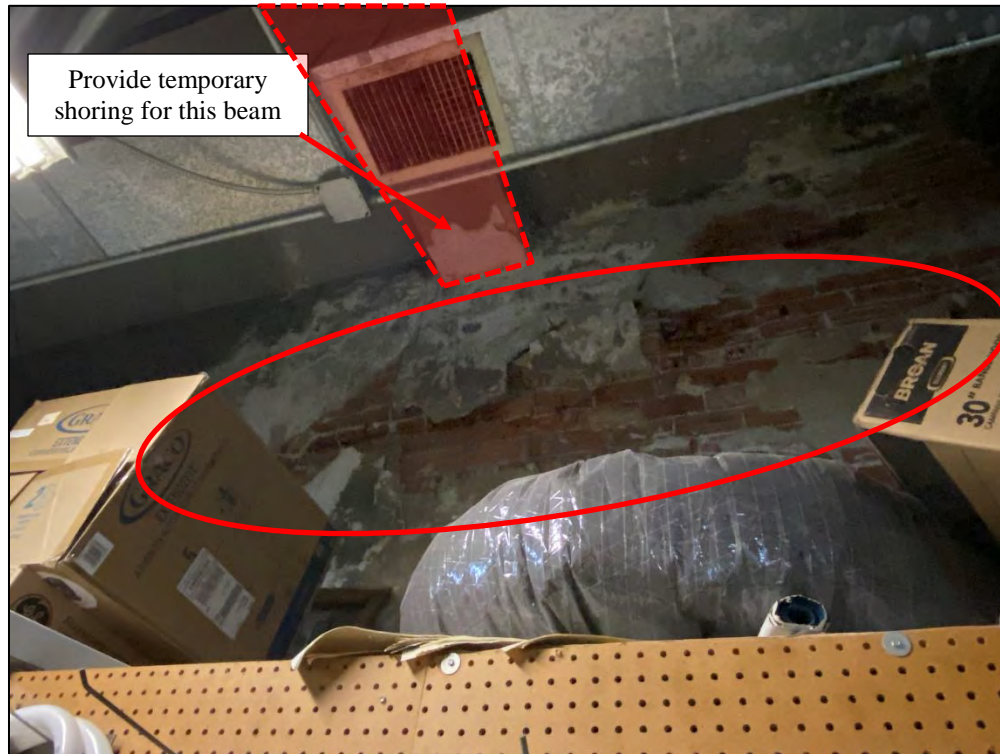
There is a storage and maintenance room on the west side of the building in which the damaged brick wall can be seen. The main area of brick damage is roughly eight feet wide by four feet high, and occurs directly below a beam which supports the second level. The beam is approximately 16 inches wide and is likely steel encased in concrete. It is unclear whether it bears on the brick wall directly or rather on a steel column encased in brick. Another, smaller, encased beam is parallel, roughly eight feet to the north. The bottom faces of the beams are roughly 15'-0" high. Both beams need to be shored with heavy posts so that permanent repairs can be applied. The permanent repairs will likely involve the replacement of the wall in this area. The on-site building maintenance team confirmed that the ductwork in this workspace along the west wall is abandoned and therefore may be removed. This will allow better access to the wall and beams above.

**Photo 1 – Damaged Brick & Beam to Support**

The main takeaway from the inspection is that this damaged area is not an imminent danger to the entire building and its residents. An evacuation or lockout of the building is not necessary at this time. The damage will still be addressed and repaired. The two beams mentioned shall be shored soon, out of an abundance of caution, but with this shoring in place the structure will be secure for the permanent, long-term repairs to take place. Another report detailing these repairs will follow at a later date.

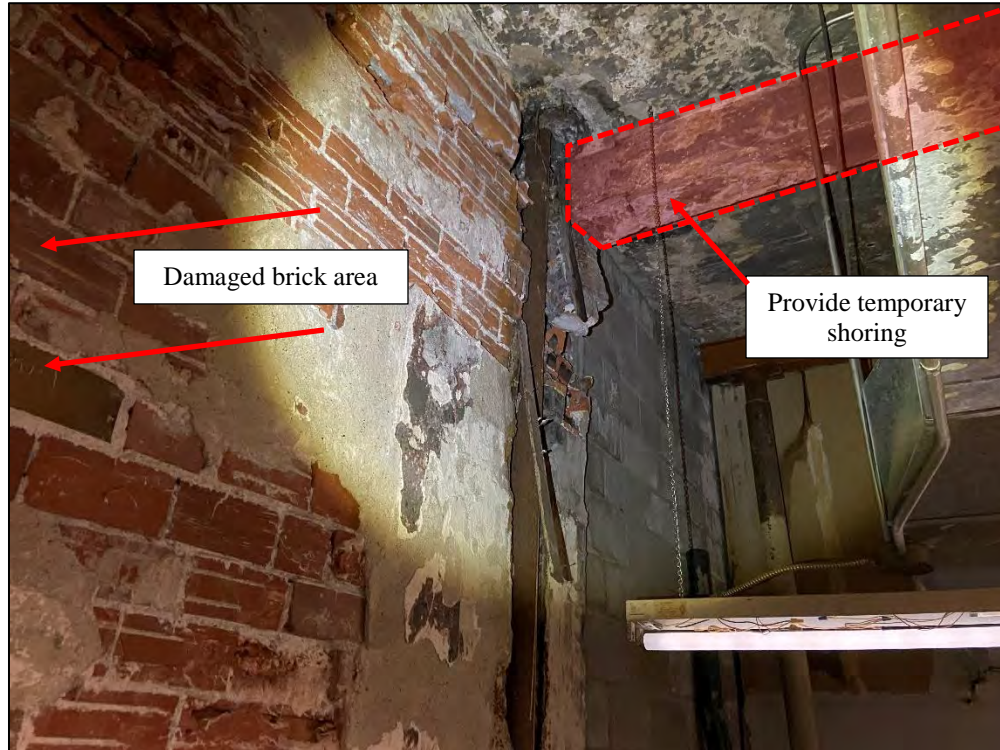
**Photo 2 – Second Beam to Support**
