# SELECT STRUCTURAL

RE: Brick Wall Repair – Addendum  
324 N. Main St.  
Davenport, IA

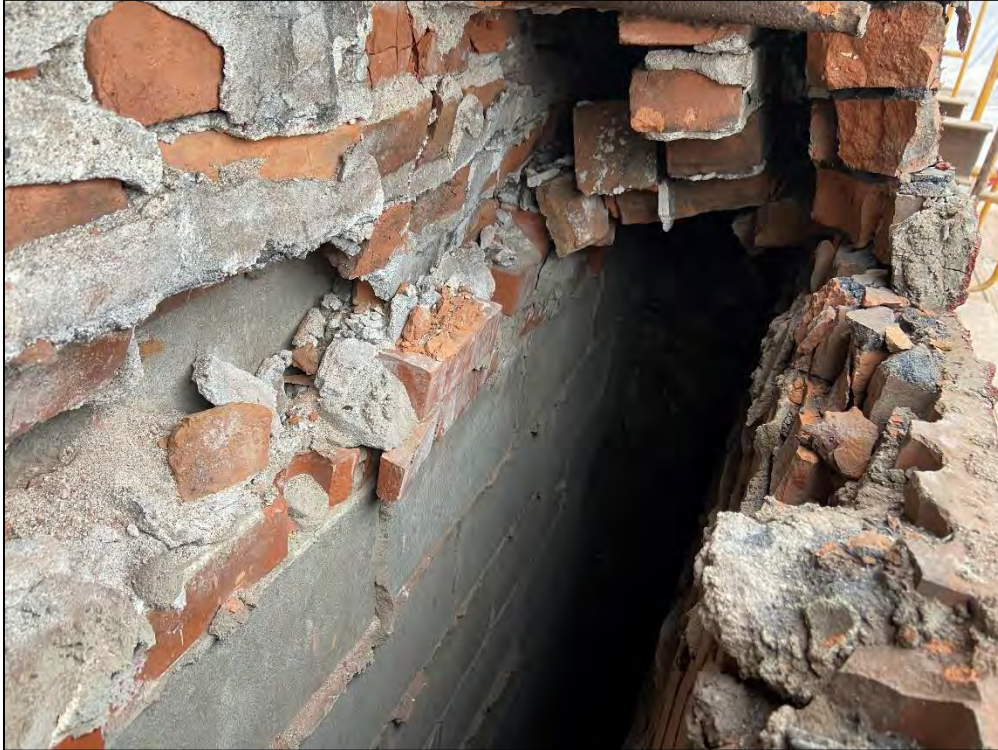
A follow-up site visit was performed at the property above on February 23<sup>rd</sup>. At the meeting, the mason pointed out that the area immediately to the north of the work area has a large and potentially dangerous void beneath the façade wythe of clay brick.

Photo 1 – Void between CMU and Clay Brick Façade

The Mason and Engineer agree that the most direct solution is to remove the brick façade in this area in a safe, controlled manner, and then to construct a second, outer layer of CMU from the ground level up to the top of the void (roughly 15 to 18 feet). This would allow the safe removal of unstable clay brick and add solid structure to the compromised wall. The repairs to the original twelve-foot-wide area of wall would proceed as it is now.

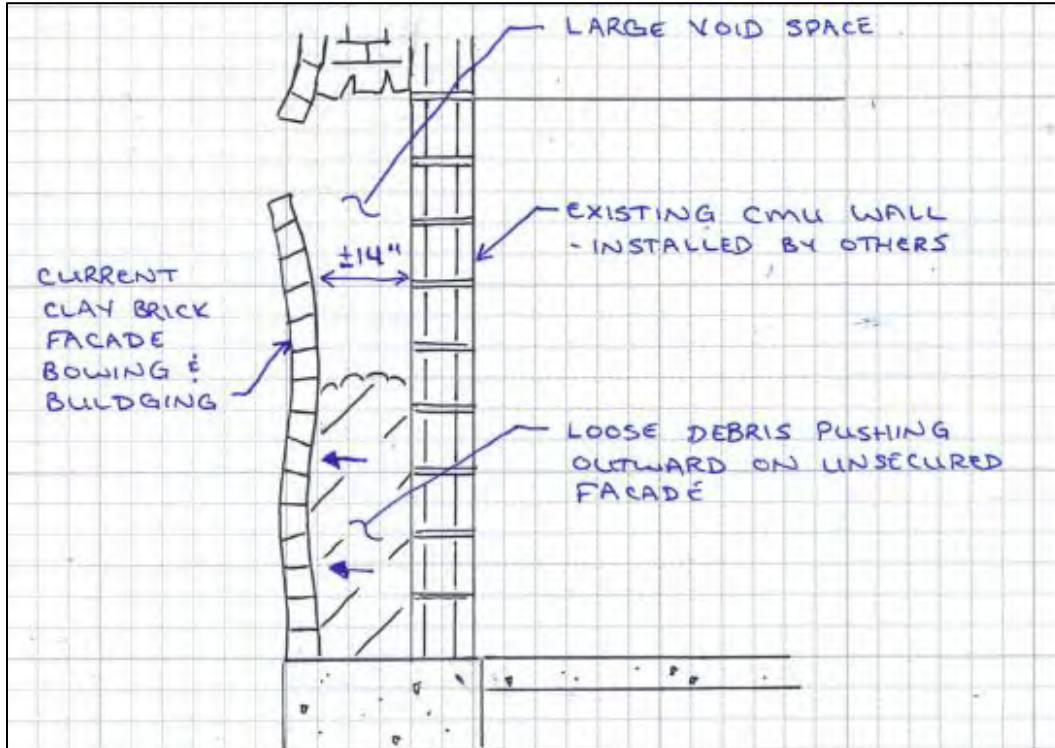
Figure 1 – Current Condition

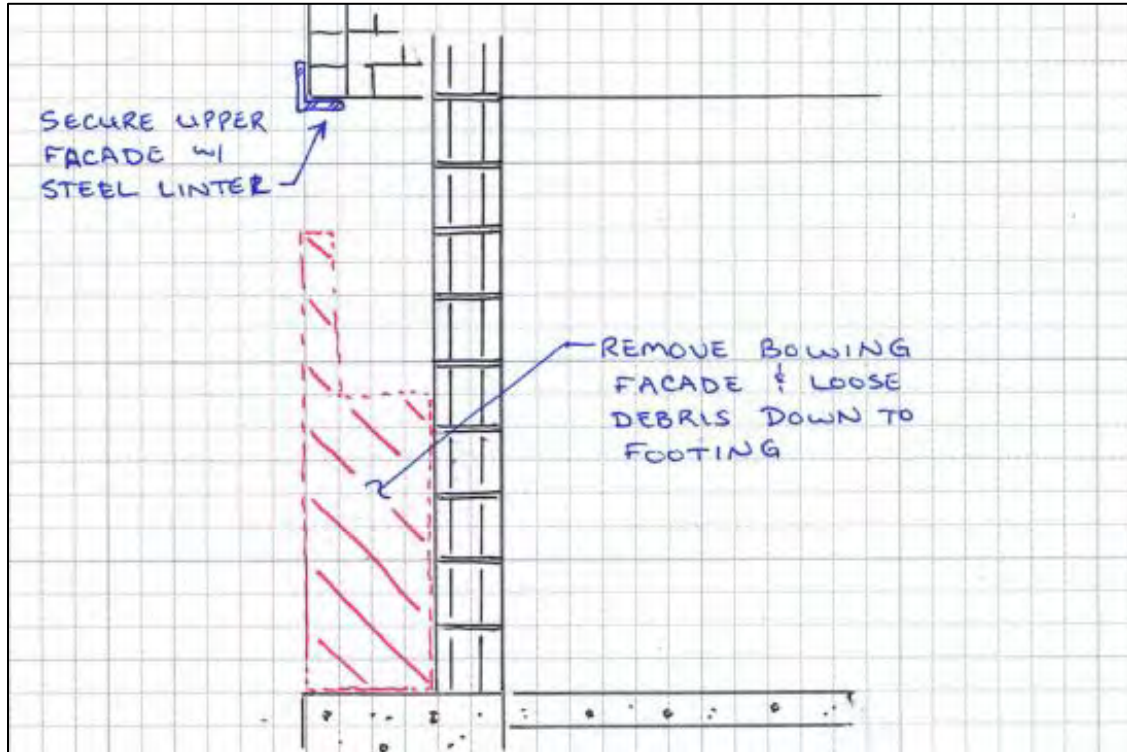
Figure 2 – Brick Demo

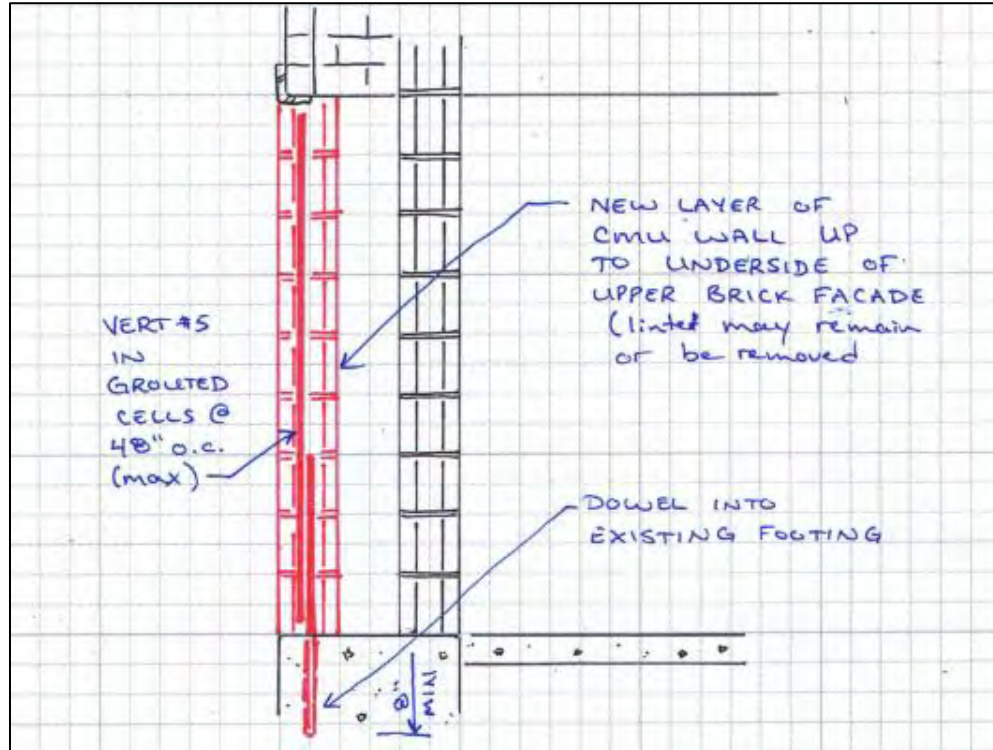
Figure 3 – New CMU Wall
