From: Chris Townsend <chris@townsendengineering.net>
Sent: Tuesday, August 18, 2020 3:29 PM
To: Morris, Jim
Cc: Haut, Tony; Mark Roemer
Subject: [EXT] 324 Main Street Davenport

Today Cory Voelkers and myself inspected the structure located at 324 Main Street in Davenport, Iowa due to some brick falling from the exterior of the 6th floor onto the sidewalk below. Photos were taken at the time of the inspection and have been included with this email.

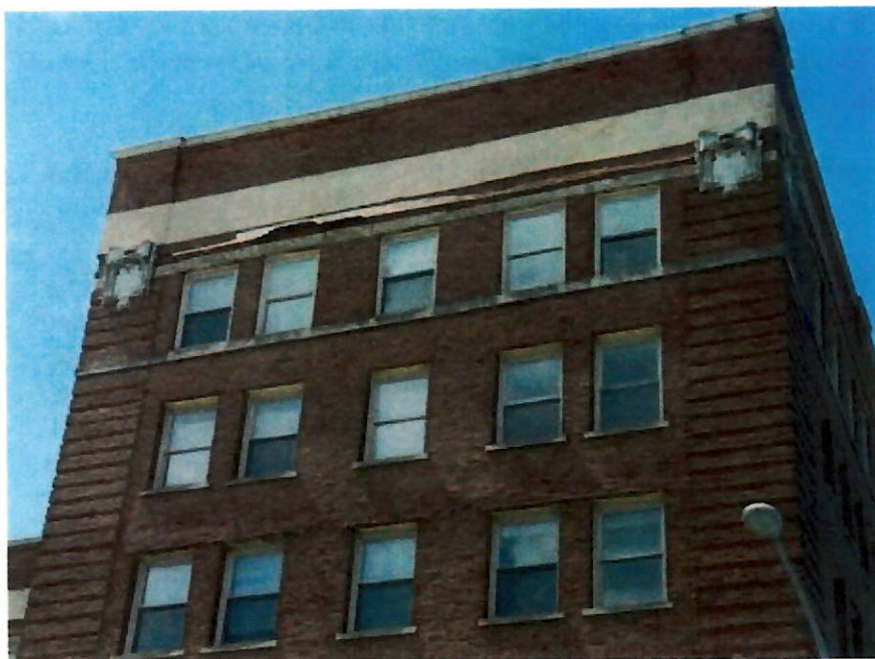
During the inspection, the primary focus was directed at the exterior brick façade on the east and north sides of the 6th floor. At the time of the inspection several bricks had fallen from the east side of the northeast corner of the building onto the sidewalk. We inspected the interior of three of the units on the 6th floor. We looked at units 601 and 602 at the northeast corner of the building and unit 615 at the southeast corner of the building. We have inspected these three units in the past three years and we could not find any noticeable cracking of the drywall or other movement when comparing today's photos with the previous inspection photos. The roof of the building was also inspected. Damage to the parapet cap was found near the southwest corner and several areas of the roofing had also been damaged during last week's storm. We did not find any recent movement of the parapet on the east side of the north or south sections of the roof and we did not find any separation of the roofing from the brick façade that would indicate any recent movement.

It is my professional opinion that the structural components of the exterior walls have not moved over the last three years but the brick façade has separated in some locations causing the brick ties to come loose which allows the bricks to fall. It was my recommendation that Bi-State Masonry either remove or stabilize all of the

1. East side of the northeast corner. Notice fallen brick above windows.

loose brick and limestone immediately to prevent more brick from falling to the ground. The brick and limestone around the area where the brick fell will be removed and any other areas that appear to have bowed out will be covered with plywood that is anchored to the interior clay block to hold the brick in place until the permanent repair is made.
